**GEOTECHNICAL ENGINEERING AND GEOLOGIC HAZARDS REPORT ON  
CAMAS WELL 6-14 TRANSMISSION MAIN PROJECT  
CAMAS, WASHINGTON**

by  
Haley & Aldrich, Inc.  
Vancouver, Washington

File No. 0208144-000  
July 2024

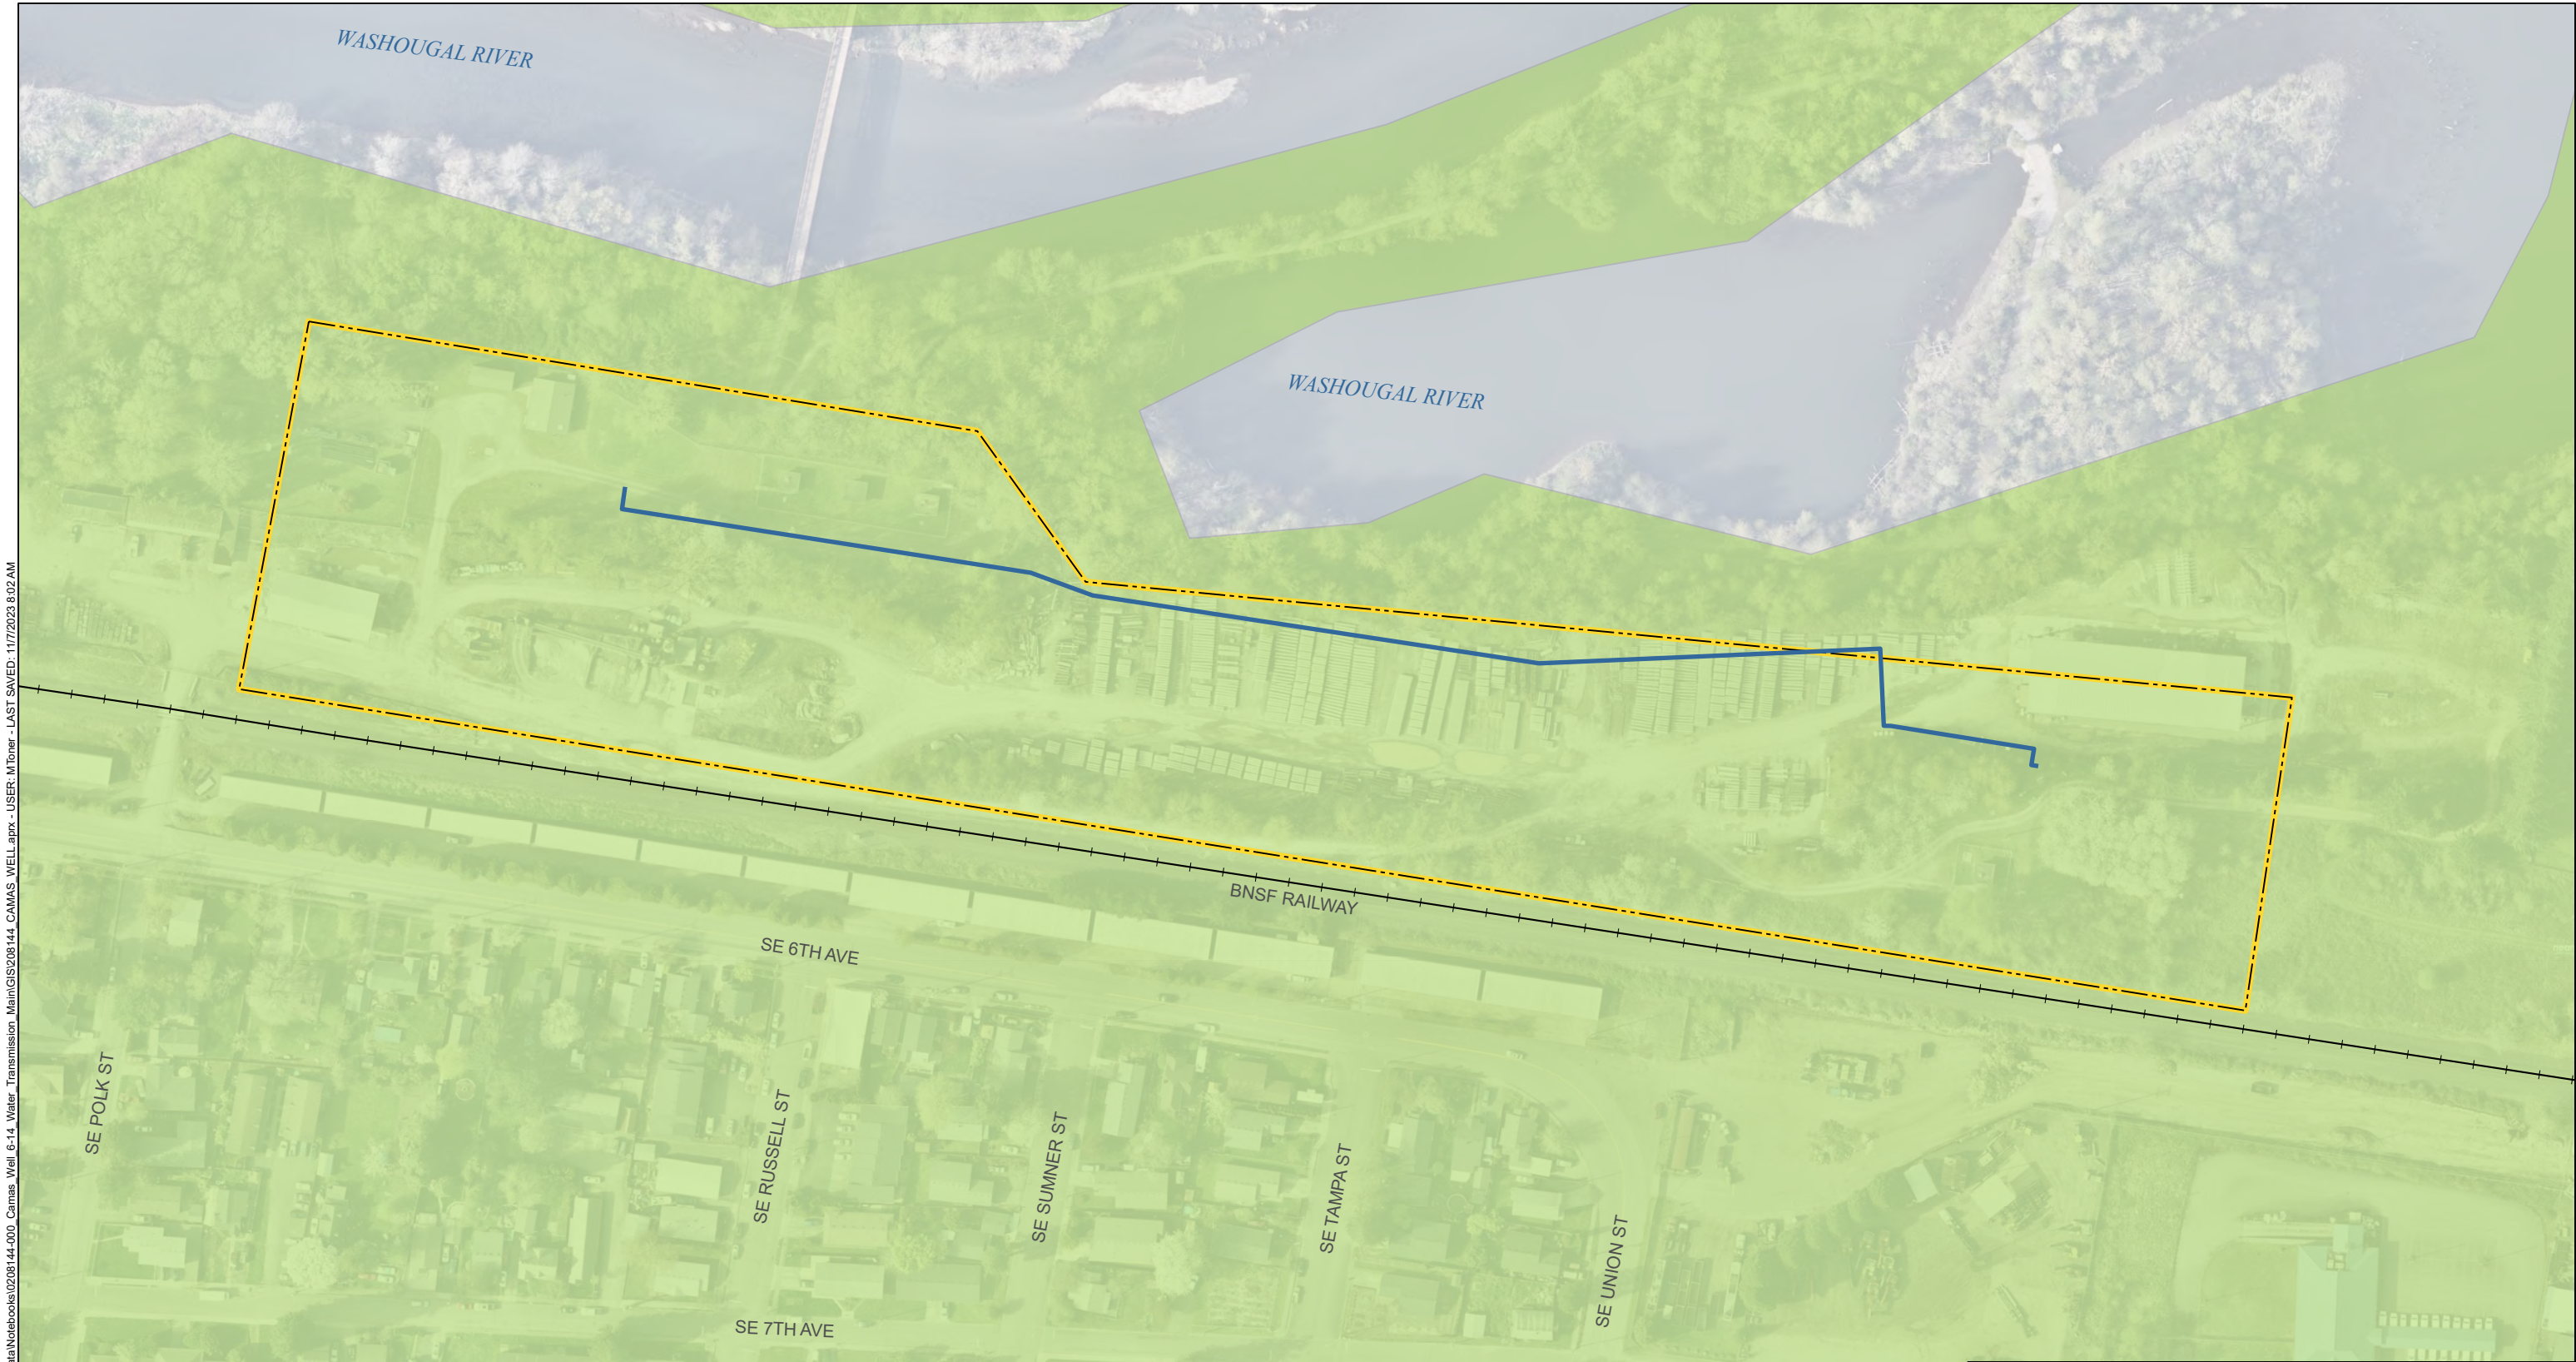
**FIGURE 6**

1. ALL LOCATIONS AND DIMENSIONS ARE APPROXIMATE.
2. LIQUEFACTION SUSCEPTIBILITY DATA SOURCE: CLARK COUNTY, WASHINGTON GEOGRAPHIC INFORMATION SYSTEM
3. ONLY MODERATE TO HIGH LIQUEFACTION SUSCETIBILITY IS PRESENT IN THE SITE AREA.
4. SITE BOUNDARY DATA SOURCE: "CRITICAL AREAS ASSESSMENT: WELL 6-14 WATER TRANSMISSION MAIN" FIGURE 1, BERGER ABAM, APRIL 2018
5. AERIAL IMAGERY SOURCE: NEARMAP, 26 APRIL 2023

CMC Chapter 16.59.040(A) references WA DNR seismic hazard maps for western Washington shown in *Figure 6 – Liquefaction Susceptibility*. The map describes the alignment to have a moderate to high liquefaction hazard.
